# FACILITY CONDITION ASSESSMENT

## Desert Healthcare District/Foundation

Project No. PC71038638

Desert Healthcare District/Foundation  
1150 N. Indian Canyon Drive  
Palm Springs, CA 92262

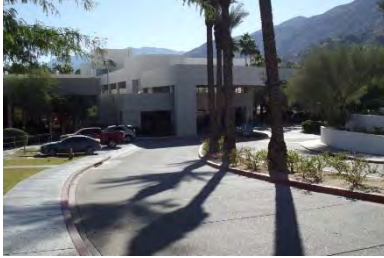
The topography of the site is generally flat, but there are some moderate elevation changes from higher elevations in the west to lower elevations in the east. Grade changes are accomplished through gentle slopes and embankments, the site is without significant retaining walls or terraces. Building drainage is generally positive with gentle slopes away from the building, or purposeful low areas with surface catch basins. Finished grade elevations on the building pad perimeter are even with the adjacent parcels. The ground floor elevations are at, or, slightly above the finished grade and pavement, except for a partial ground floor level, under a portion of the building which is partially below grade.

Storm water drains via sheet-flow to a system of catch basins or curb inlet structures that drain into the municipal system. Underground piping, generally reinforced concrete pipe, connects the catch basins and inlet structures together to provide delivery to the storm water system. Some roof drains are piped underground to the storm water system as well.

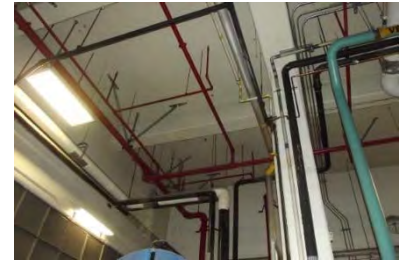
Based on our representative areas of observation, the building did not reveal any evidence of apparent structural distress. The building's foundation system appears stable with no visible indications of adverse subsoil conditions such as subsidence. Our general observations of the rooflines and sidewalls revealed them to be level and plumb, respectively, to the unaided eye. Generally, the structural framing for the floors and roof, based on the areas surveyed, appeared to be in good condition. For the most part, there were no excessive deflections noted that would affect the serviceability of the framing systems.

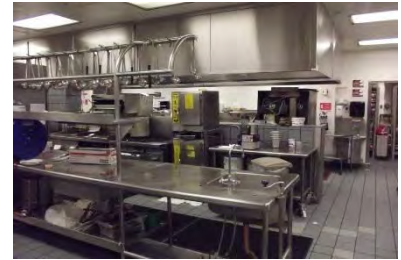
Interior areas were in generally good condition with some deferred maintenance and deficiencies noted and detailed in the cost schedule. The hospital has been added and expanded over the years resulting in some inefficiencies in traffic flow and material handling.

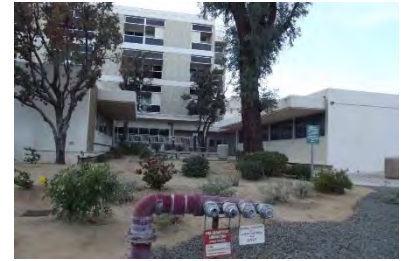
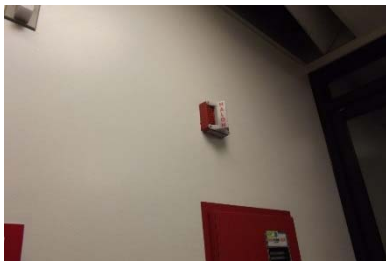
There are numerous wet risers in the structures. Each branch and floor has a manual shut-off valve with anti-tamper switch. Each floor has a flow alarm sensor installed. There are 2.5-in. hose connections at each floor and rooftops, as well as distributed firewater hose stations. Firewater piping is steel pipe with grooved / clamped "Victaulic" type joints, but some smaller branches are steel pipe with threaded joints. The sprinkler system is tagged as having last Regulation 4, Five-Year test and certification by "Shasta Fire Protection Co." in 2013 – so it is due again in April 2018. Last annual test and certification by "Shasta" was completed in October 2017. Sprinkler heads were noted as varied types and vintages. Heads observed

on site included Viking 2014, 3-mm quick release glass bulb type for newer built-out areas and 1970s CSC-C bi-metallic fused link type for older spaces. Note the NFPA requires sprinkler heads to be replaced every 50 years. "Dry type" fire extinguishers are also installed. A spot check of extinguishers indicated they were last serviced by "Fire Master" on October 16, 2017, less than one year of the date of this report, indicating an up-to-date service but due the month of this inspection.
